Manhole Inspection Summary

Manhole # S33EE_051MH

Insp Date: **2/24/07 11:18 AM**

Location Address: **PARK AVE**

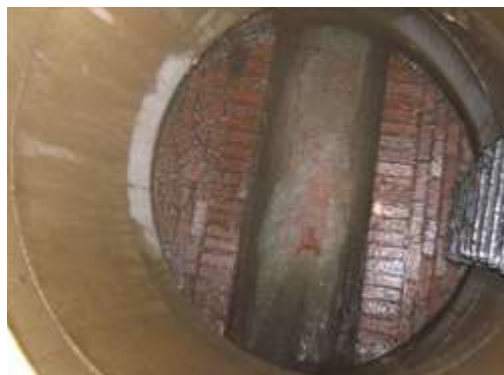
Top View

Bench debris.

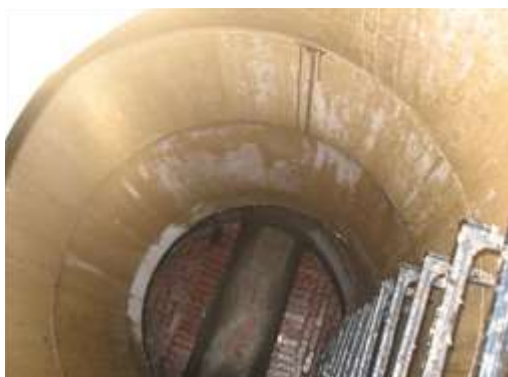
Defect

Corbel and Barrel infiltration.

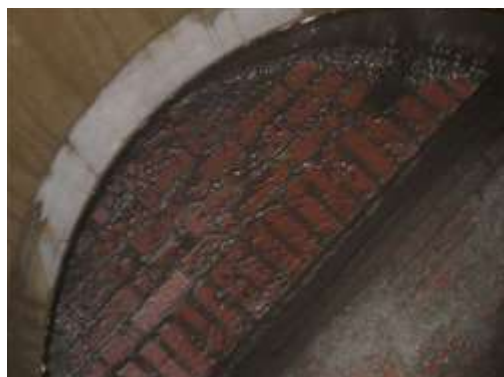
Defect

Barrel infiltration.

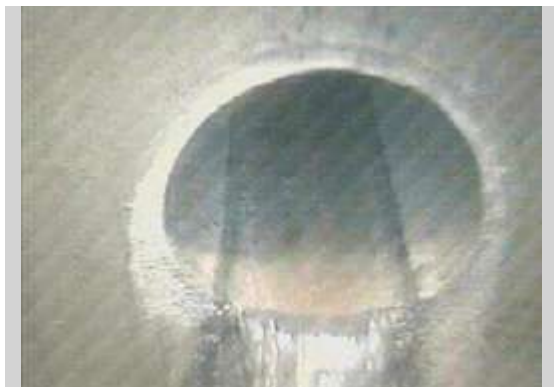
Pipe In @ 6 O'Clock

Infiltration: **Evidence**

Drop: **Outside** Rod and Bar
